Air Accident Investigation Unit Ireland

FACTUAL REPORT

**ACCIDENT
ELA AVIACION SL, ELA 07S, EI-FSR
Spanish Point Airfield, Co. Clare**

18 March 2022

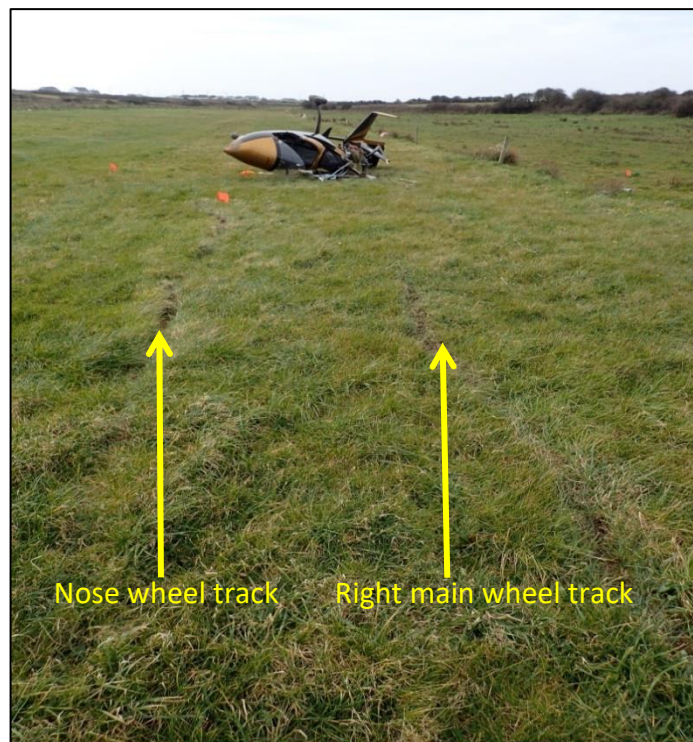
The Pilot stated that as he advanced the throttle and with the gyroplane gaining speed, 'we were pushed over to the right side' towards the boundary fence. The Pilot closed the throttle to abort the take-off but was unable to recover directional control. The gyroplane departed the side of the runway, impacted with a fence, and came to rest lying on a magnetic heading of 105 degrees (**Photo No. 1**).

Photo No. 1: Final position of gyroplane

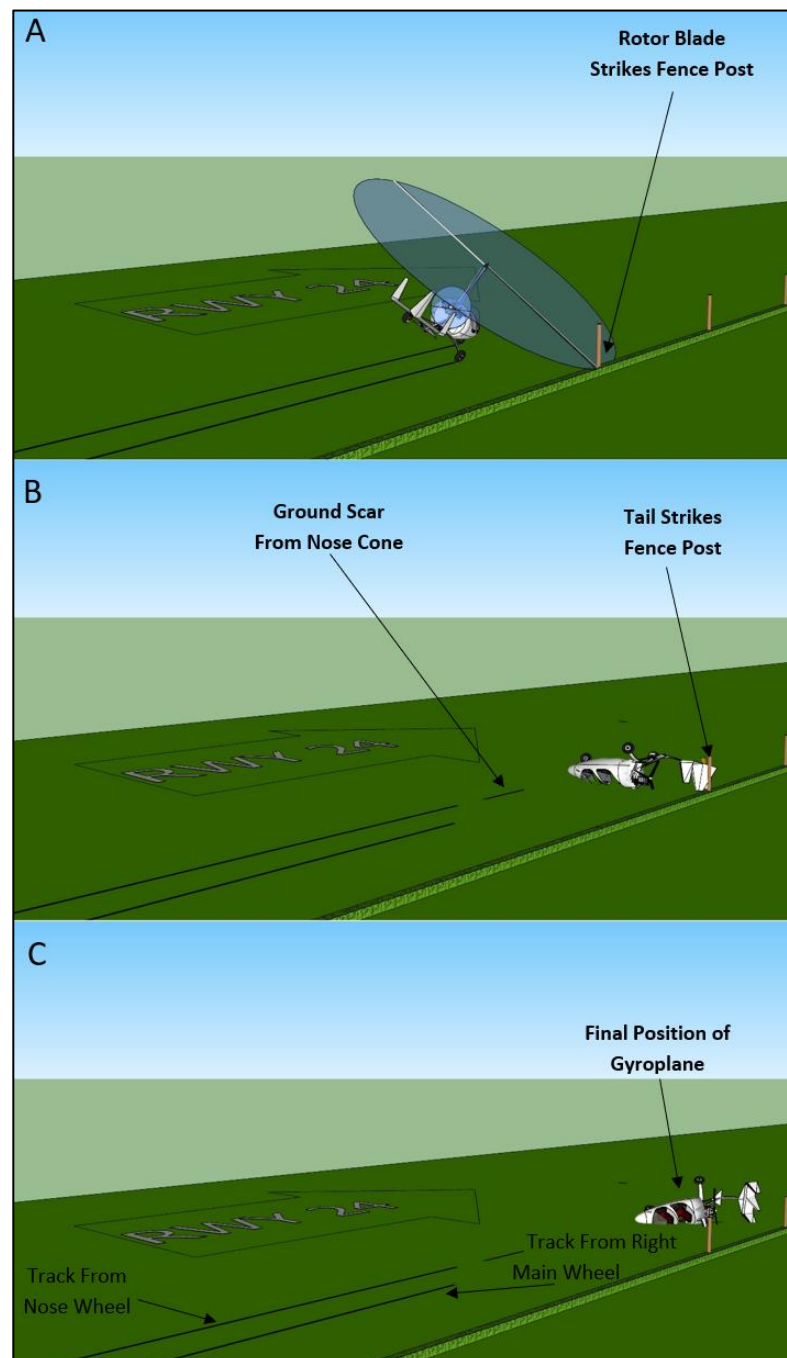
When the gyroplane departed from the runway centreline it commenced a roll to the right and the main rotor struck a post in a fence running parallel to the runway (**Figure No. 1A**). The gyroplane continued to roll, became inverted with the tail impacting another fence post (**Figure No. 1B**). The gyroplane came to rest lying on a magnetic heading of 105 degrees (**Figure No. 1C**).

Figure No. 1: Illustration of likely accident sequence

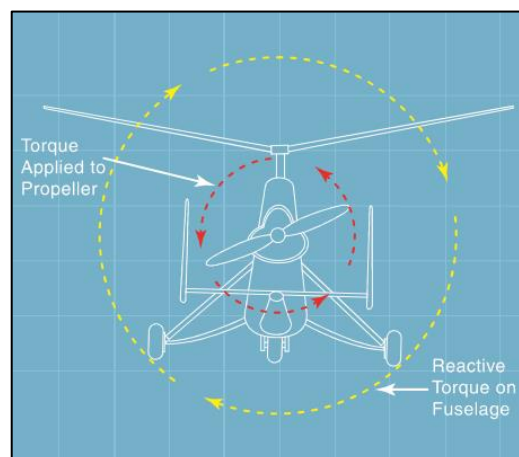
When viewed from behind, the propeller on the gyroplane type rotates in an anti-clockwise direction and induces a reactive torque in a clockwise direction. Engine torque effect is more noticeable at high power settings such as at take-off or go around (**Figure No. 2**).

Figure No. 2: Engine torque (FAA Rotorcraft Flying Handbook)

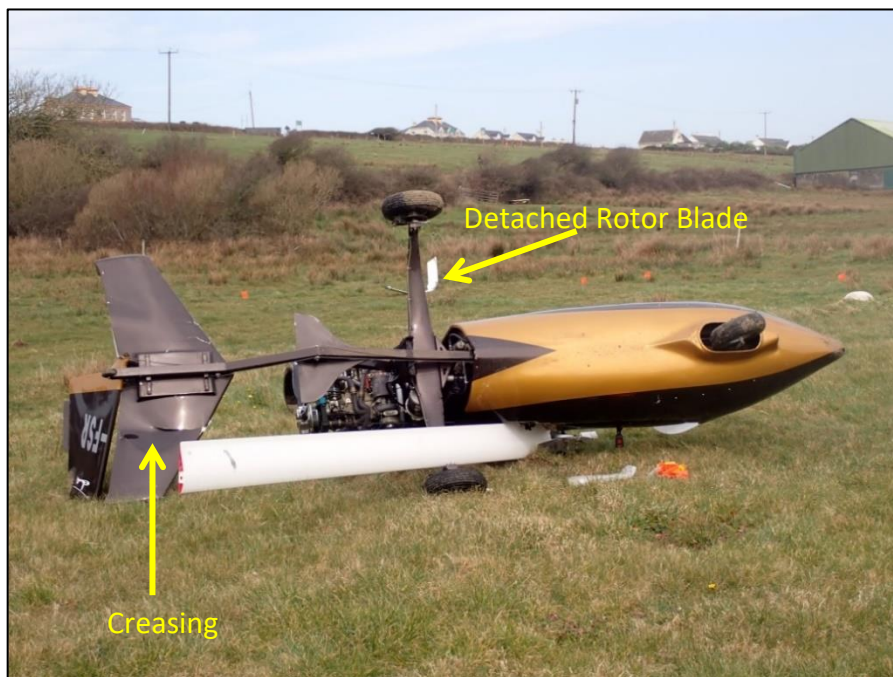
There was significant damage to the rotor blades with one blade detaching from the hub bar during the accident sequence and coming to rest approximately 23 metres (m) from the main wreckage. The remaining blade remained connected to the hub bar at the rotor head. There was chord-wise creasing of the left horizontal stabiliser (**Photo No. 2**). The main rotor mast had fractured and separated with significant distortion of the control rods. The rudder detached from the vertical stabiliser. Sections of two of the propeller's blades had completely separated while the third blade sustained significant cracking and distortion (**Photo No. 3**).

Photo No. 2: Damage to stabiliser and rotor blades

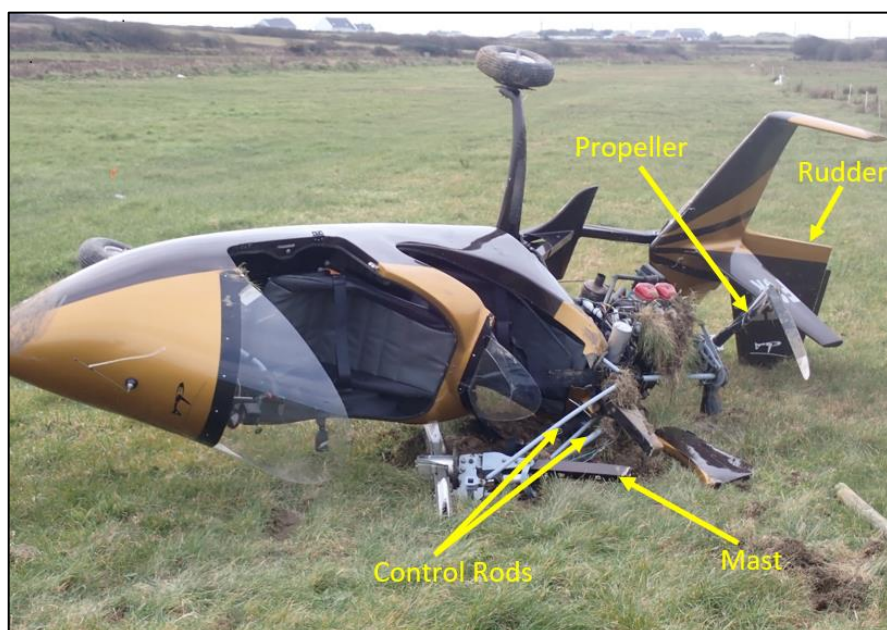
Photo No. 3: Damage to control rods, mast, propeller and rudder

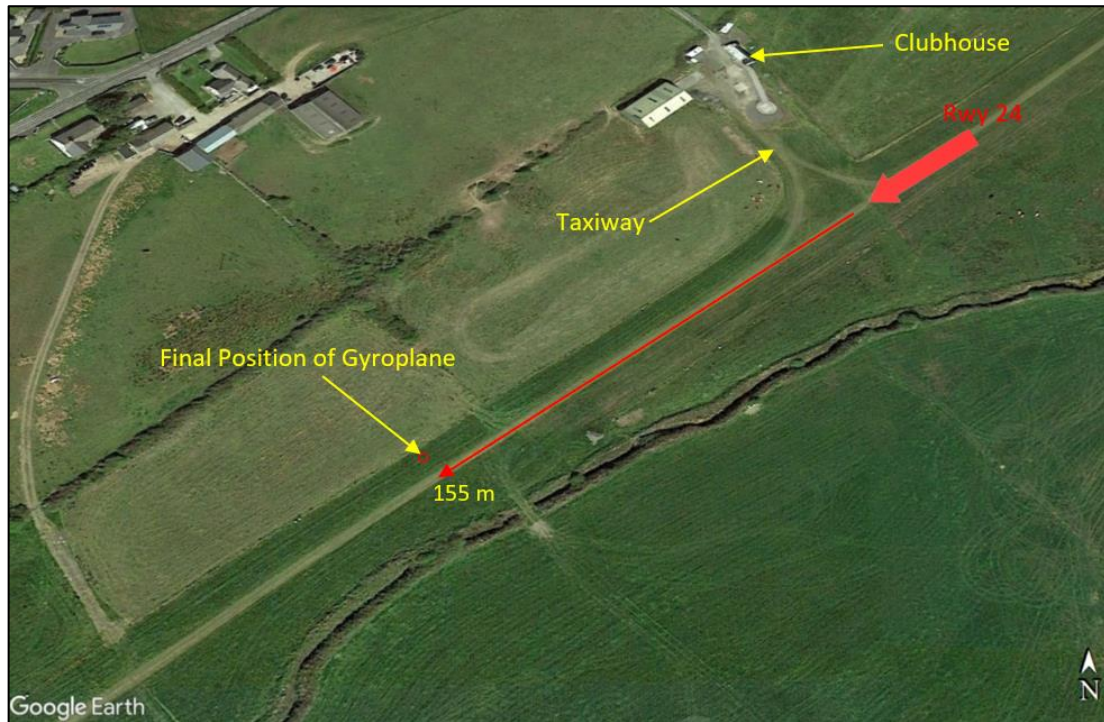
Spanish Point Airfield is located 18.5 nautical miles west of Ennis, Co Clare. The airfield is at an elevation of 110 ft above mean sea level. Pooley's Flight Guide states it has a single grass runway 600 m in length, designated 24/06. The distance from commencement of the take-off run to the final position of the gyroplane was 155 m (**Figure No. 3**).

Figure No. 3: Final position of Gyroplane
